**EMERGENCY SPILLWAY PERFORMANCE,
UPPER RED ROCK CREEK WATERSHED,
OKLAHOMA**

ARS-S-108

May 1976

By W. O. Ree¹

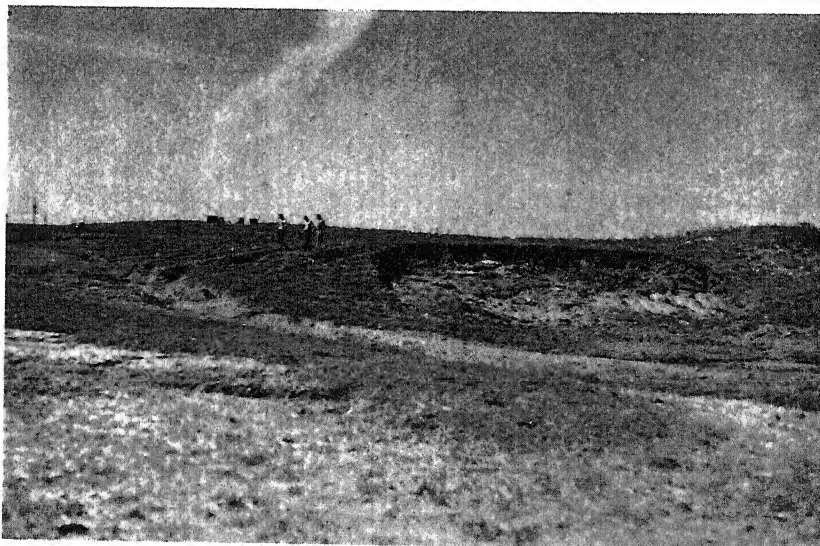
FIGURE 3.—Outlet end of site 24 emergency spillway after flood of October 10-11, 1973.

upon which the spillway discharges. The badly scoured portion to the right is on the bank of a natural channel or gully alongside the emergency spillway and was attacked by overflow from the spillway. Figure 4 shows the rills in the lower end of the spillway.

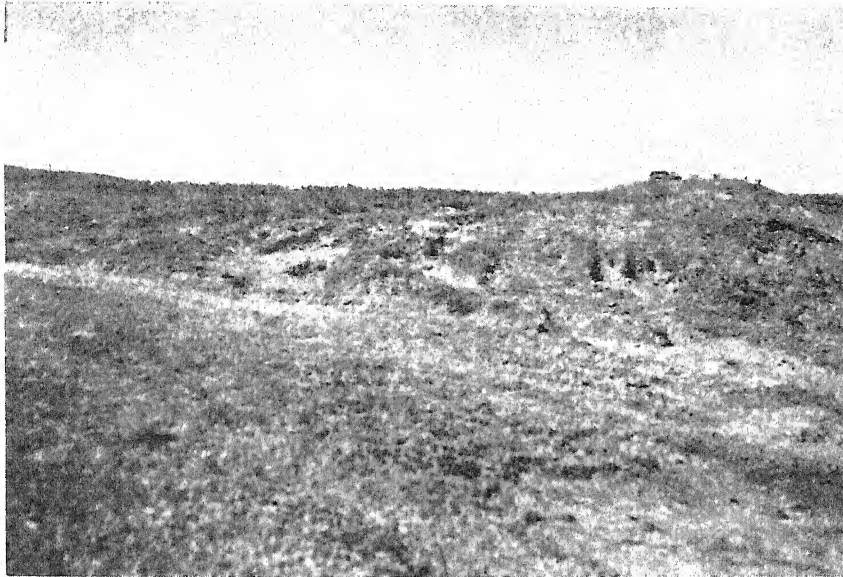
FIGURE 4.—Lower end of site 24 emergency spillway after flood of October 10-11, 1973.

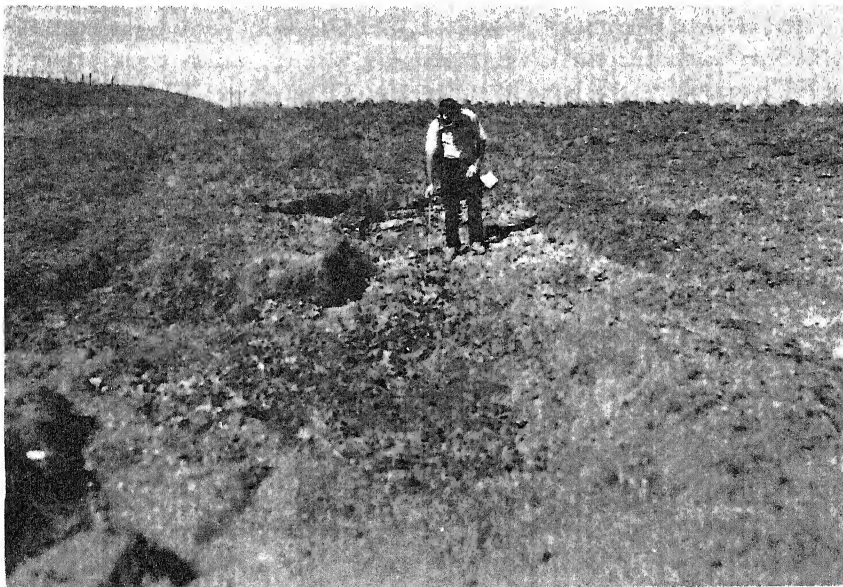
FIGURE 5.—Two-foot scour to the shale bedrock 90 feet downstream from site 24 spillway crest.

Figure 5 is a closeup view of the head of one of the deeper rills. The scour here is about 2 feet deep and extends to the shale bedrock. This part of the spillway was subjected to the 6.7 feet per second flow velocity. Immediately downstream of the spillway crest is a small area scoured to a depth of 5 inches (fig. 6).

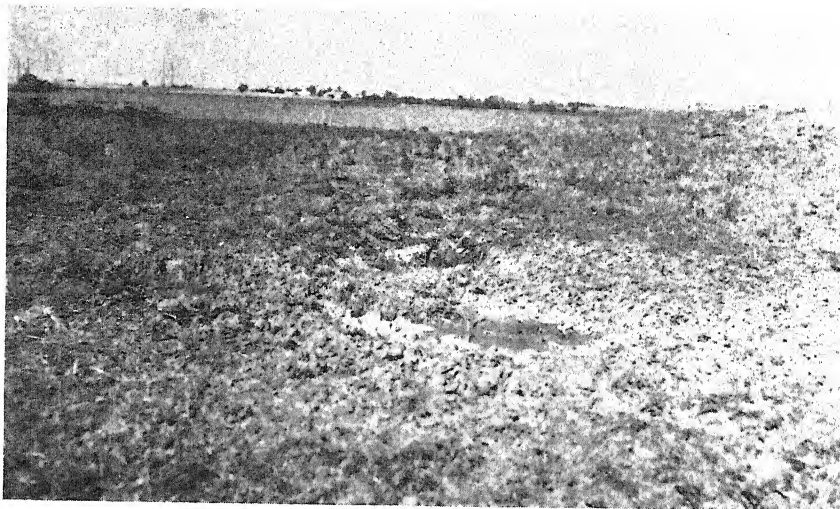
FIGURE 6.—Scoured area in site 24 spillway just downstream from spillway crest. The cover on the adjoining area is thin, poor, and short.

The site 24 spillway started to erode during a flow event which had a peak mean velocity of 6.7 feet per second. The spillway appeared to have been heavily grazed, and this may have been responsible for its condition. Cattle trails and “stomp” areas were present in the spillway at the time of inspection. Therefore, it is reasonable to assume that the eroded areas also had suffered from similar cattle activity.

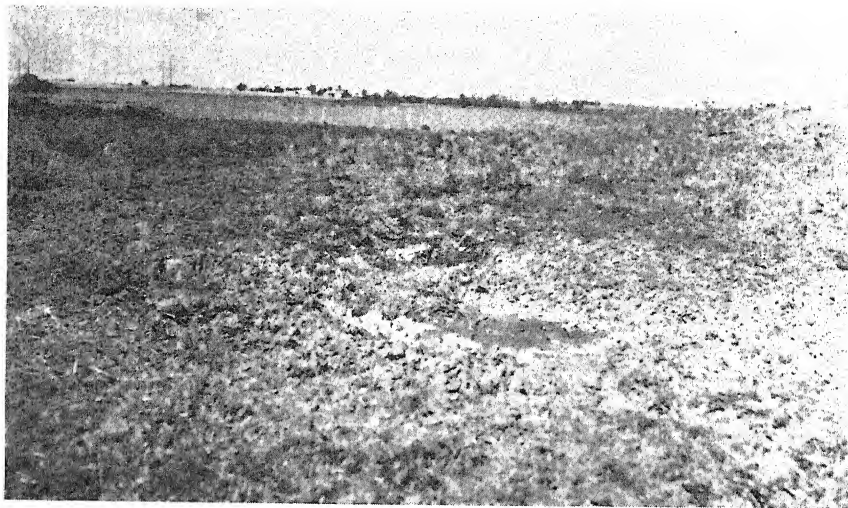
FIGURE 6.—Scoured area in site 24 spillway just downstream from spillway crest. The cover on the adjoining area is thin, poor, and short.

The site 24 spillway started to erode during a flow event which had a peak mean velocity of 6.7 feet per second. The spillway appeared to have been heavily grazed, and this may have been responsible for its condition. Cattle trails and "stomp" areas were present in the spillway at the time of inspection. Therefore, it is reasonable to assume that the eroded areas also had suffered from similar cattle activity.

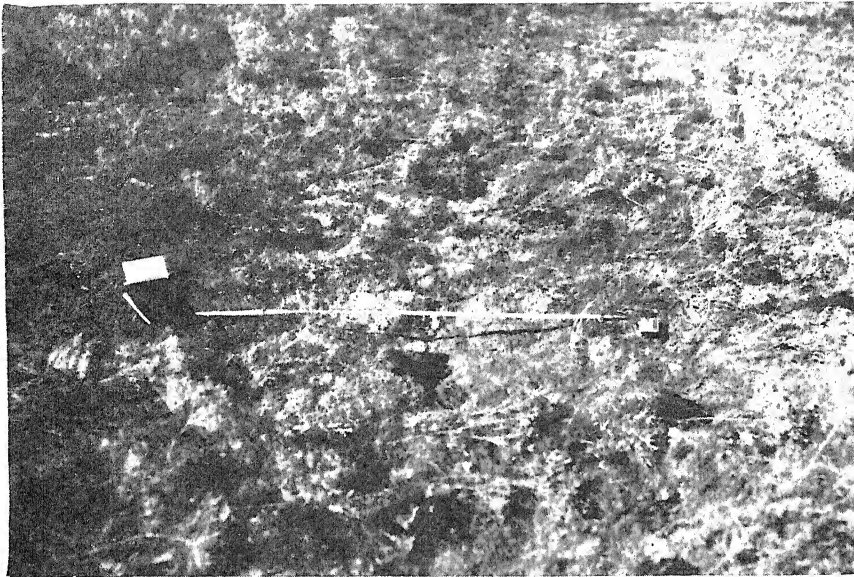
The spillway was in excellent condition after the flood. Some slight erosion was evident about 20 feet downstream from the crest and about 40 feet in from the right bank (fig. 8). It is not known whether this eroded area was present before the flood or whether there had been a weak spot in the cover here. An overall view of the spillway is shown in figure 9.

FIGURE 8.—Closeup of most eroded portion of site 25 emergency spillway after flow event of October 10–11, 1973. This point in the spillway is located approximately 20 feet downstream from the crest and about 40 feet in from the right bank. There appears to be more broomweed here, which may be a weaker cover in this area. Its appearance before the flood is not known.

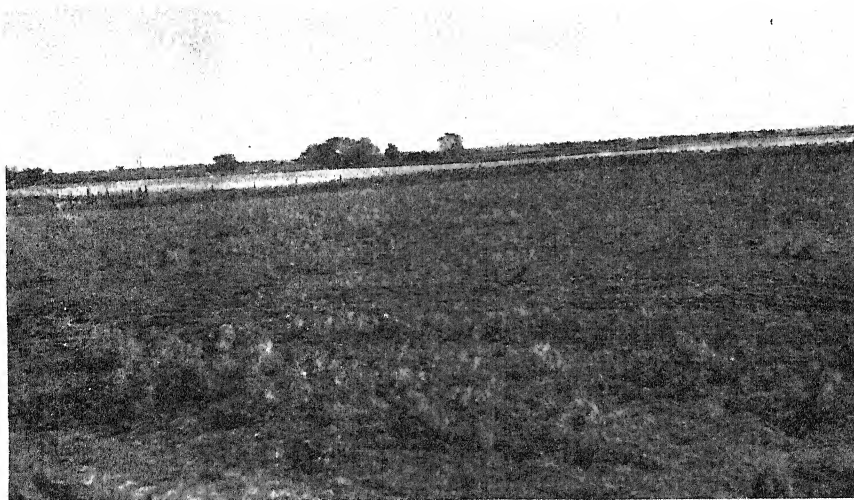
The excellent condition of the spillway should be expected because the flow velocity of 5.6 feet per second is below a suggested permissible velocity of 8 feet per second for a bermudagrass cover on clay soil and slopes of less than 5 percent, as determined from the "Handbook of Channel Design for Soil and Water Conservation" (cited in footnote 2). Uniformity of cross section and cover and moderate grazing can also be given some credit for the fine performance of the spillway.

FIGURE 9.—Overall view of site 25 emergency spillway after flow event of October 10–11, 1973. This spillway is in excellent condition. The cover is closely grazed bermudagrass, with a scattering of broomweed and some small, fine-leaved grass.

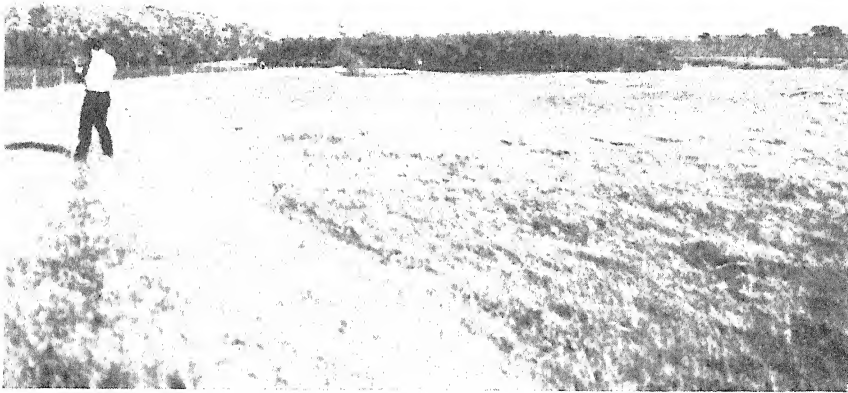
The flow velocity in the upper part of the spillway was estimated to have been 1.0 feet per second at the peak of the flood. This low velocity did not erode the spillway; the grass has hardly been disturbed. Figure 11 shows the crest of the spillway after the flow.

FIGURE 11.—Crest of emergency spillway, site 30. The cover is an excellent stand of bermudagrass.

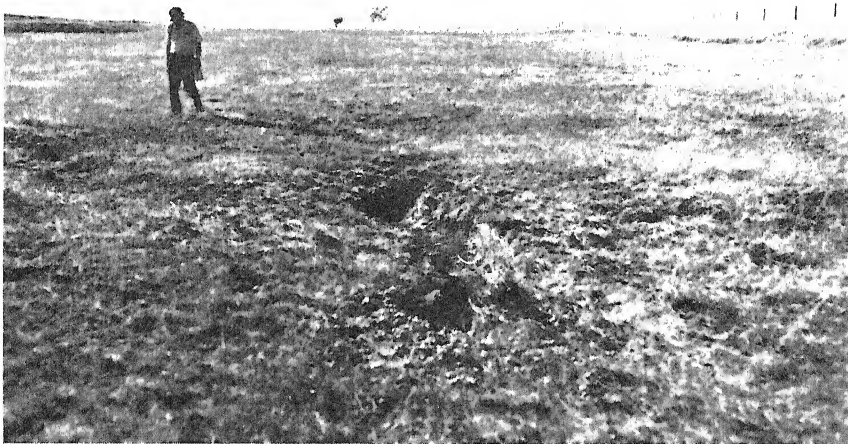
the topography of the site. A small gully has formed here (fig. 12). (It may have been there before, only to be enlarged by the flood.)

FIGURE 12.—Small gully at outlet end of site 30 emergency spillway. Concentration of flow and the poor cover may have caused this minor failure.

Second, at the outlet the spillway was gradually deepened at the centerline so it could join the existing draw in a smooth transition. The flow is concentrated at the deepest point of the spillway,

where the velocity is highest and where the gully starts. (It could eventually reach the center.) A level sill and a low drop structure at the terminal end of the spillway would eliminate the need for the deepening that threatens the stability of the spillway. This would be a practical solution only if the grass could be relied upon to provide protection against erosion in the channel upstream from the terminal structure. If the grass lining is not dependable, there would be no point in using a terminal structure because the spillway could still fail from erosion above the structure. Again, the exploration of this idea is left for future consideration.
